## CASE STUDY

Holiday Lodges, Inverness, Scottish Highlands

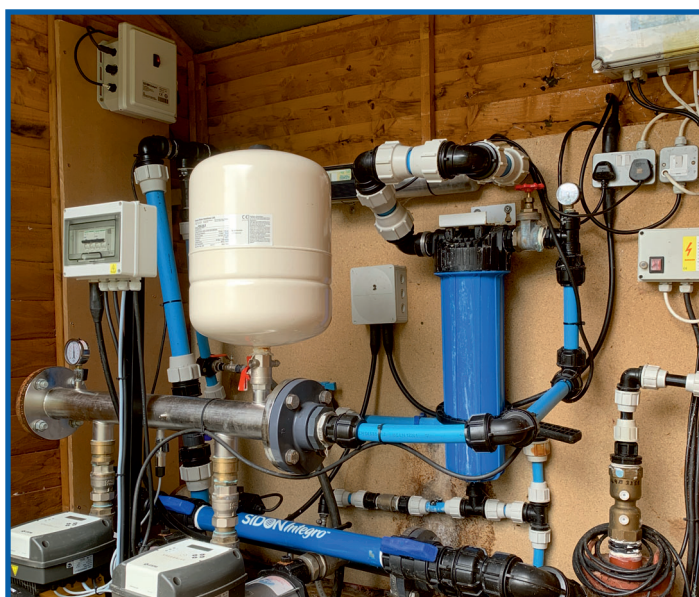
Integro™ 2 Installed June 2021

In June 2021, we installed an Integro 2 v3 in the pump room to protect the entire system which services the main house and three lodges, all with private hot tubs.

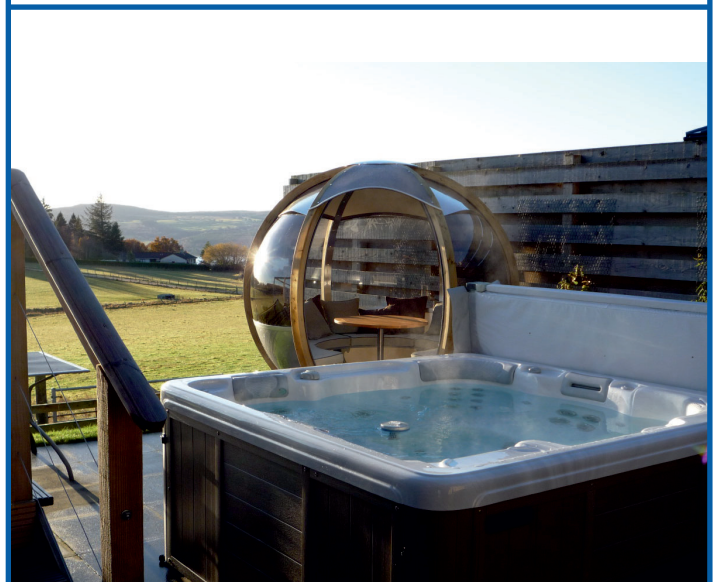
### One of the four Hot Tubs

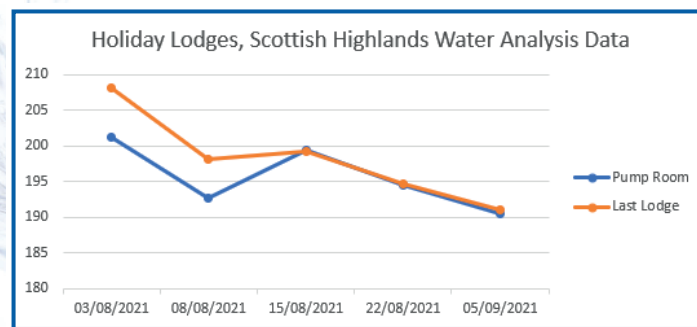
As part of this study, in the weeks following installation of the Integro, additional water samples were taken and analysed. The results are shown in the graph below. The blue line shows water samples taken from the point that the Integro is installed in the pump room and the orange line shows water samples taken from the lodge which is at the furthest point from the pump room. As the water source is a borehole, the levels of hardness may vary from day to day. The significant thing to note from this data is the gap between the data points for the first and second set of results compared to that of the subsequent three results. Following installation, the Integro begins to break down historical scale build-up and the minerals dissolve back into the water as it flows through the system, explaining why the hardness level is higher at the furthest point. But it can be clearly seen that following several weeks of operation, historical scale has been removed from the system to the extent that there is no longer a noticeable difference in hardness at the two testing points.

An initial water analysis report carried out in May 2021 gave a water hardness as CaCO<sub>3</sub> level of 206.8mg/l.

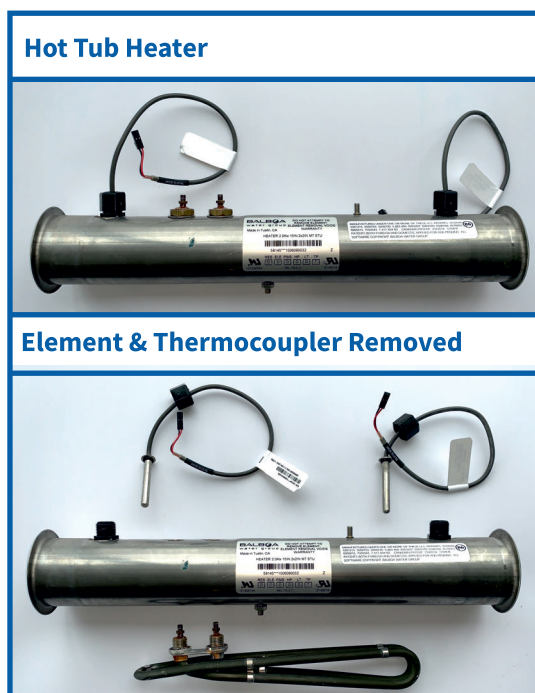
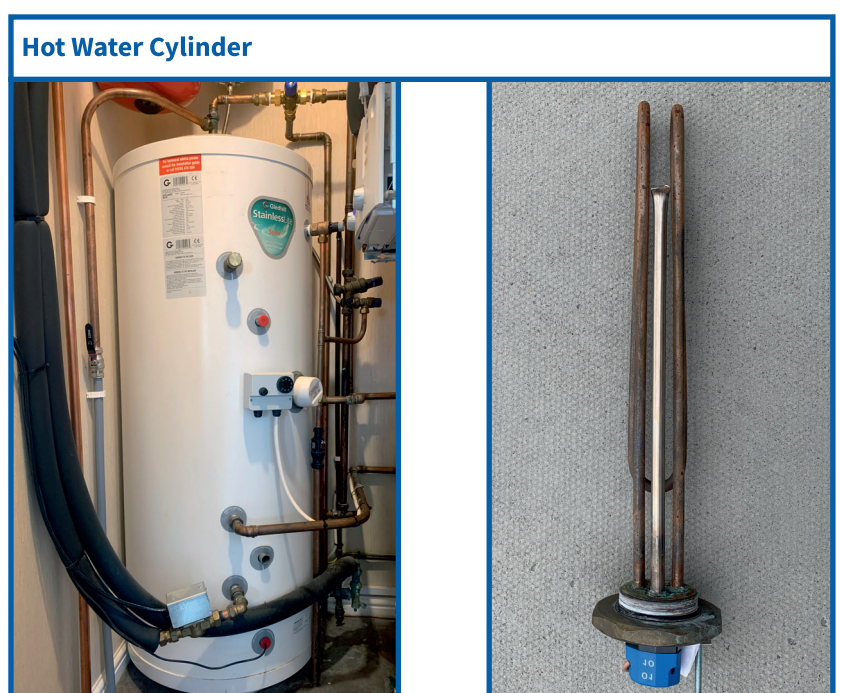
In March 2022, engineers were on site to service the boilers, water cylinders and hot tubs. Inspection revealed that they were completely free of any scale build-up. Specifically, heating elements were removed from one of the hot tubs and one of the water cylinders (10-11 years old), both were completely free from any signs of limescale.
