## CASE STUDY

Randolph Hotel By Graduate Hotels, Oxford, UK

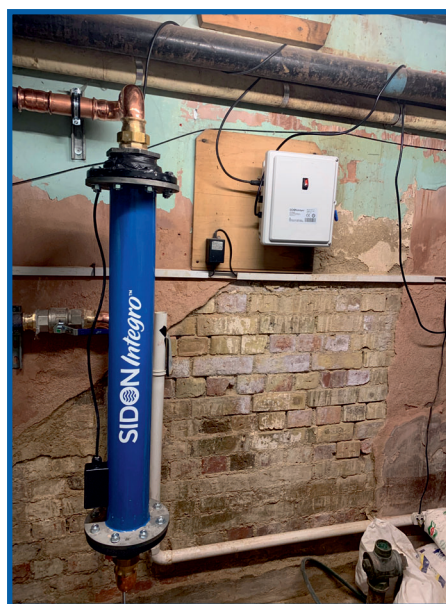
*Integro™ 4* on the mains water supply

In December 2020, after the site survey and discussion with the Maintenance Manager, an Integro™ 4 was installed on the mains water supply covering the cold-water tank and system. In addition, and for extra protection to the hot water system, an Integro™ 2 v3 was installed directly before the calorifier.

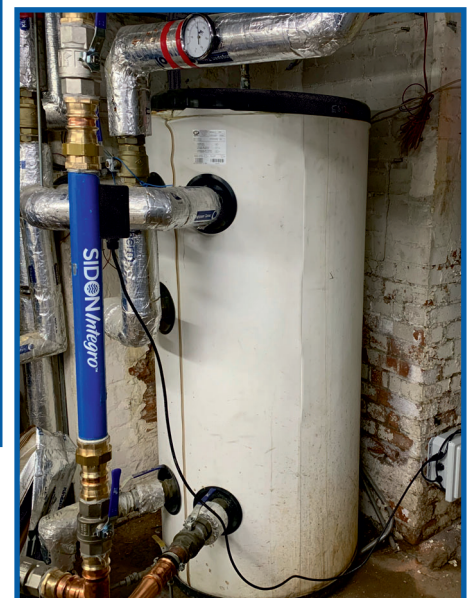
*Integro™ 2* before the calorifier
