CASE STUDY

T&C Ice Company, Mississippi, USA

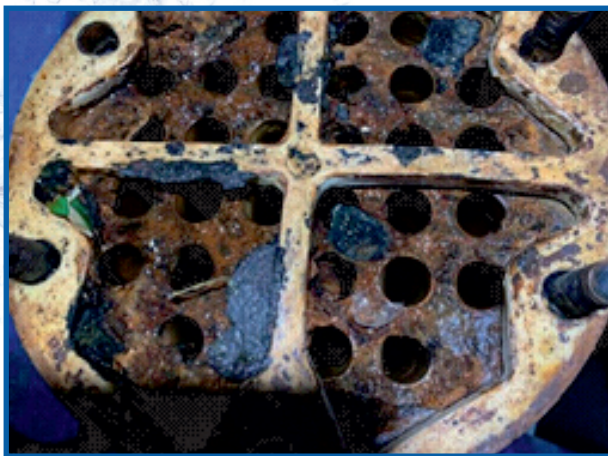
Image of #1 Condenser prior to installation

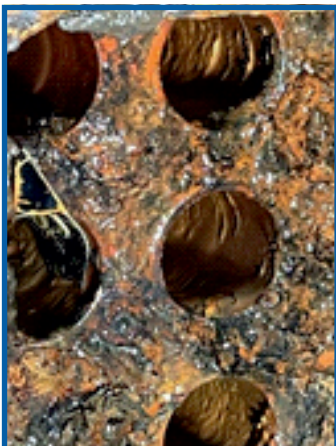
Scaled tubes in #1 condenser prior to Integro™ installation

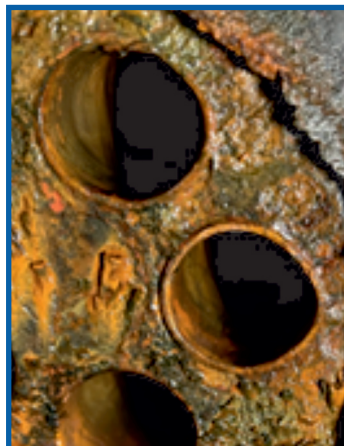
The Integro™ systems removed historical scale build up in the condensers, which the owner observed when he opened the condenser plates on December 20, 2020, March 1, 2021 and December 30, 2021. Further observational findings were:

*December 2020 - **Scale build-up reduced***

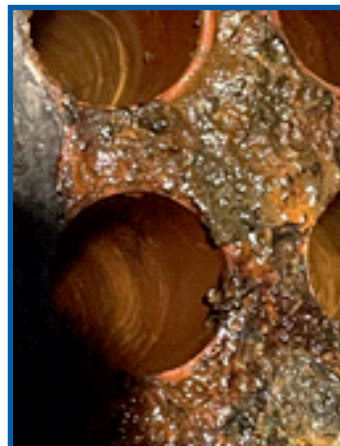
*March 2021 showing **scale removed***

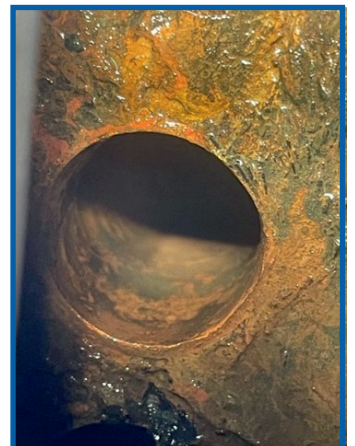
*December 2021 - Condenser tubes remain **scale free***
