CASE STUDY

Tankless Water Heater – Chula Vista, California, USA

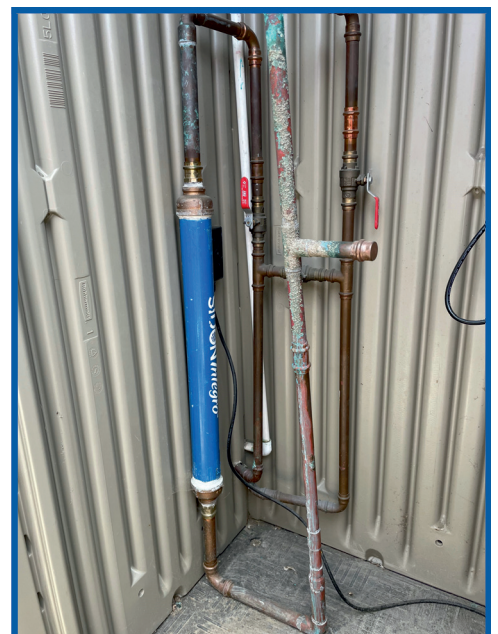
This picture, taken at the time of installation, clearly shows a hardwater problem as seen in the visible build up of scale on the pipework caused by a small amount of water leakage over time.

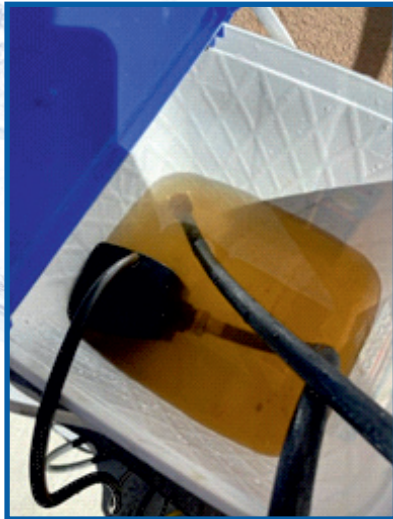
First chemical flush shows **no scale debris**

In December 2021, nine months after the installation of the Integro™, the Rheem tankless water heater was flushed with the descaling chemical prescribed by the manufacturer. Since the tankless water heater had never been descaled or flushed since its installation over 6 years ago, he expected to see a large amount of hard water scale debris flushed out of the coils of the water heater. Both the initial chemical flush and the subsequent flush with water were clear and had almost no debris or residue. In his words, **“It is awesome!”**

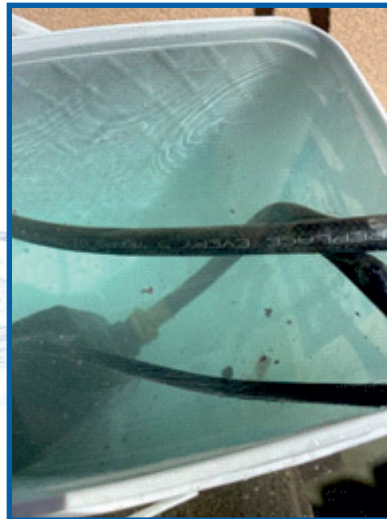
Following flush with water, again virtually **no scale debris**

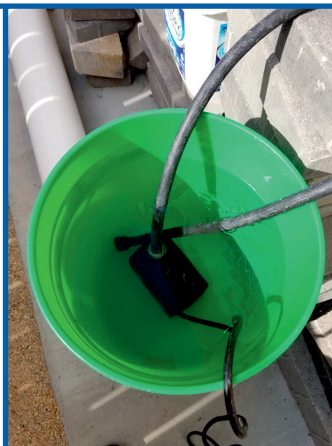
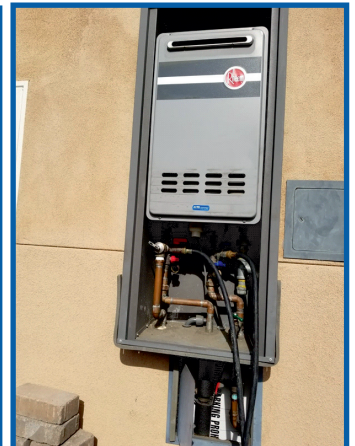
On March 3, 2022, the owner decided to once again flush the Rheem tankless heater to see if it had remained clean since the initial flush in December 2021. There was absolutely no scale debris or discoloration of the chemical solution while the Rheem tankless heater was flushed for approximately one hour. The chemical solution being used remained clear throughout the flushing.

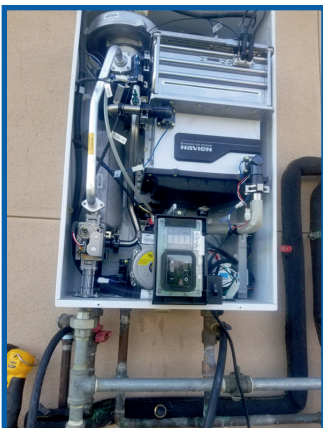
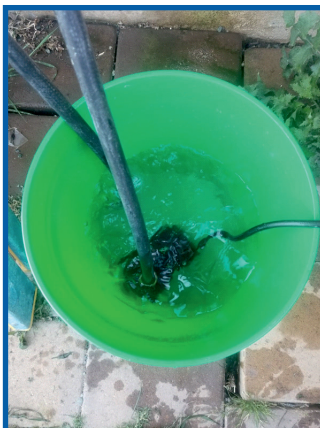
Also on March 3, 2022 the owner wanted to descale and flush his second tankless heater installed at his home, a Navien model MPE 210A. This Navien unit had been installed approximately 3 years ago and had also never been descaled and flushed. The chemical solution came out perfectly clear from the moment the chemicals started cycling through the tankless heater coils. No residual scale discoloration or debris of any kind was observed.
